Project closure report

Acoustek

NIA_SGN0044

July 2016

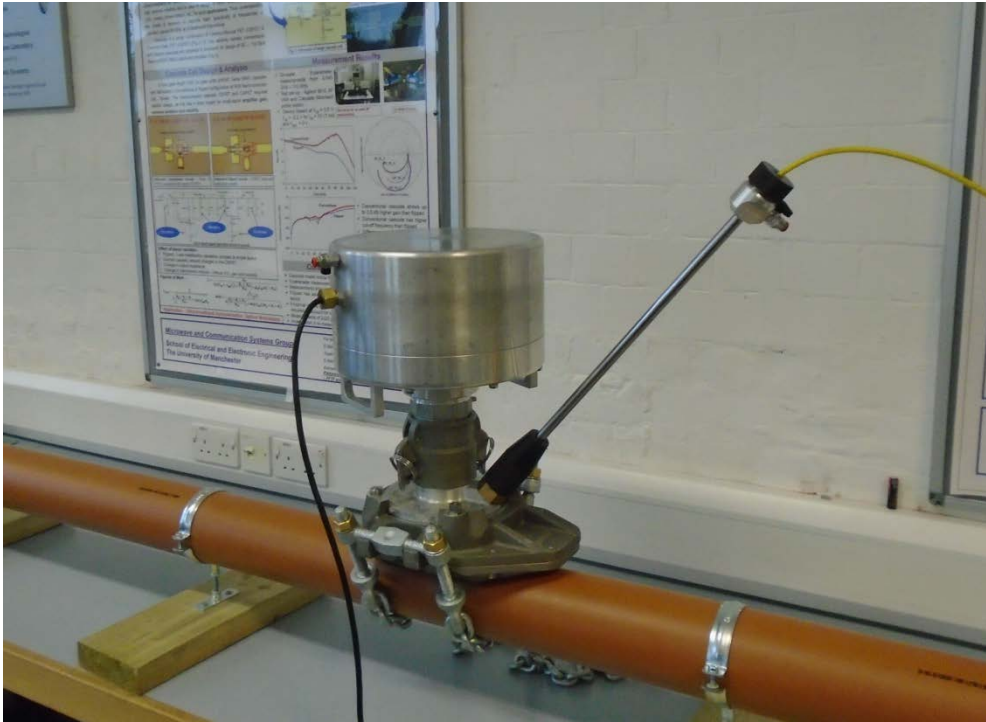
Figure 013 shows the complete hardware assembly that attaches to the gas main; this assembly is made up of 5 components, the WASK base, the WASK adapter, the speaker, the microphone launch tube and the microphone cable, as per Figure 014.

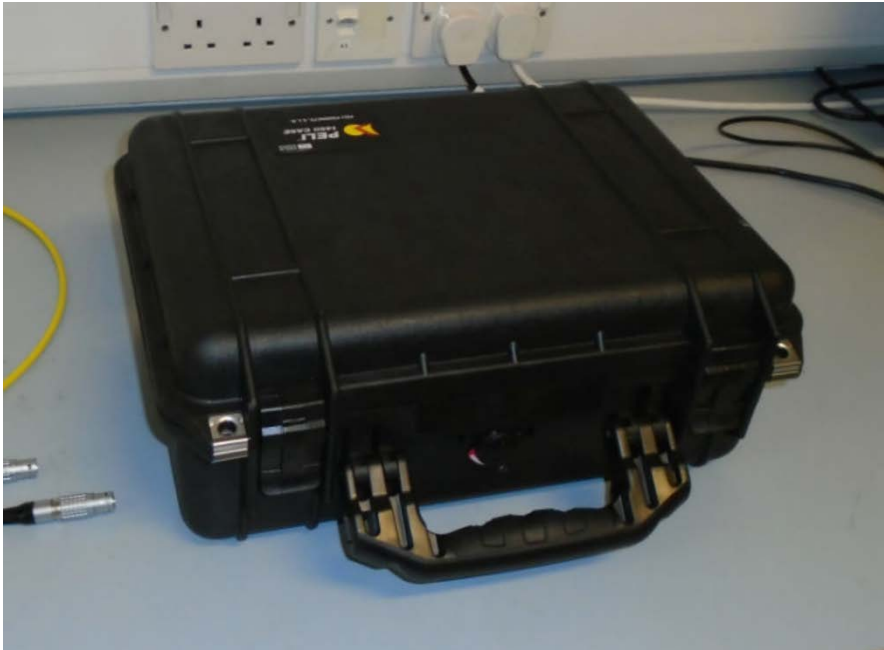
Figure 015

The Peli case (Figure 015) contains all of the electronics required to drive the Acoustek® system; the laptop (Figure 016) sits neatly inside the Peli case.

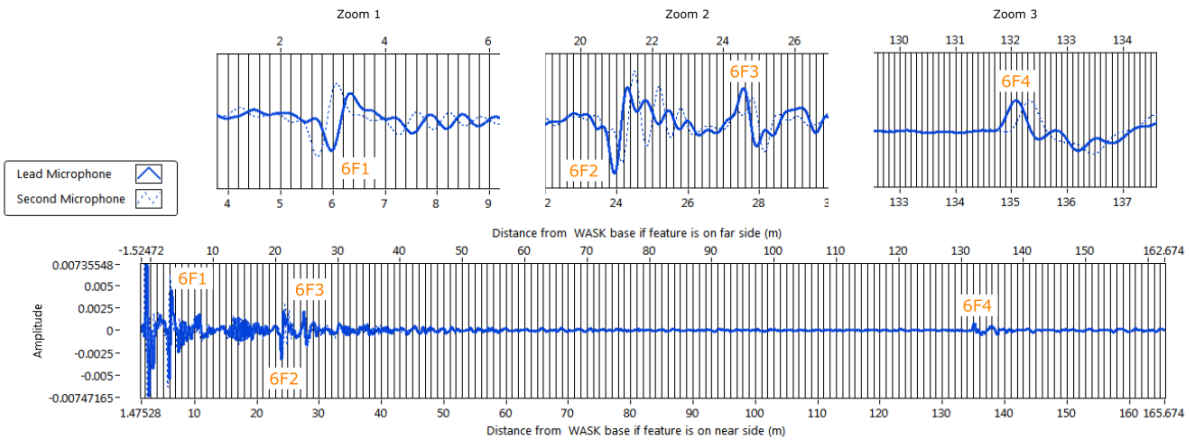
Figure 020

Feature code	Features detected	Direction	Distance	Confirmed	Location error
6F1	Large branch/expansion	Dir 2	3 m	Siphon visible at 3.3 m	9.1 %
6F2	Large branch/expansion	Dir 1	23.7 m	Equal tee found by camera at 23.6 m	0.4 %
6F3	Suspected branch cap	Dir 1	27.3 m	No	N/A
6F4	Large blockage or cap	Dir 1	134.8 m	No	N/A

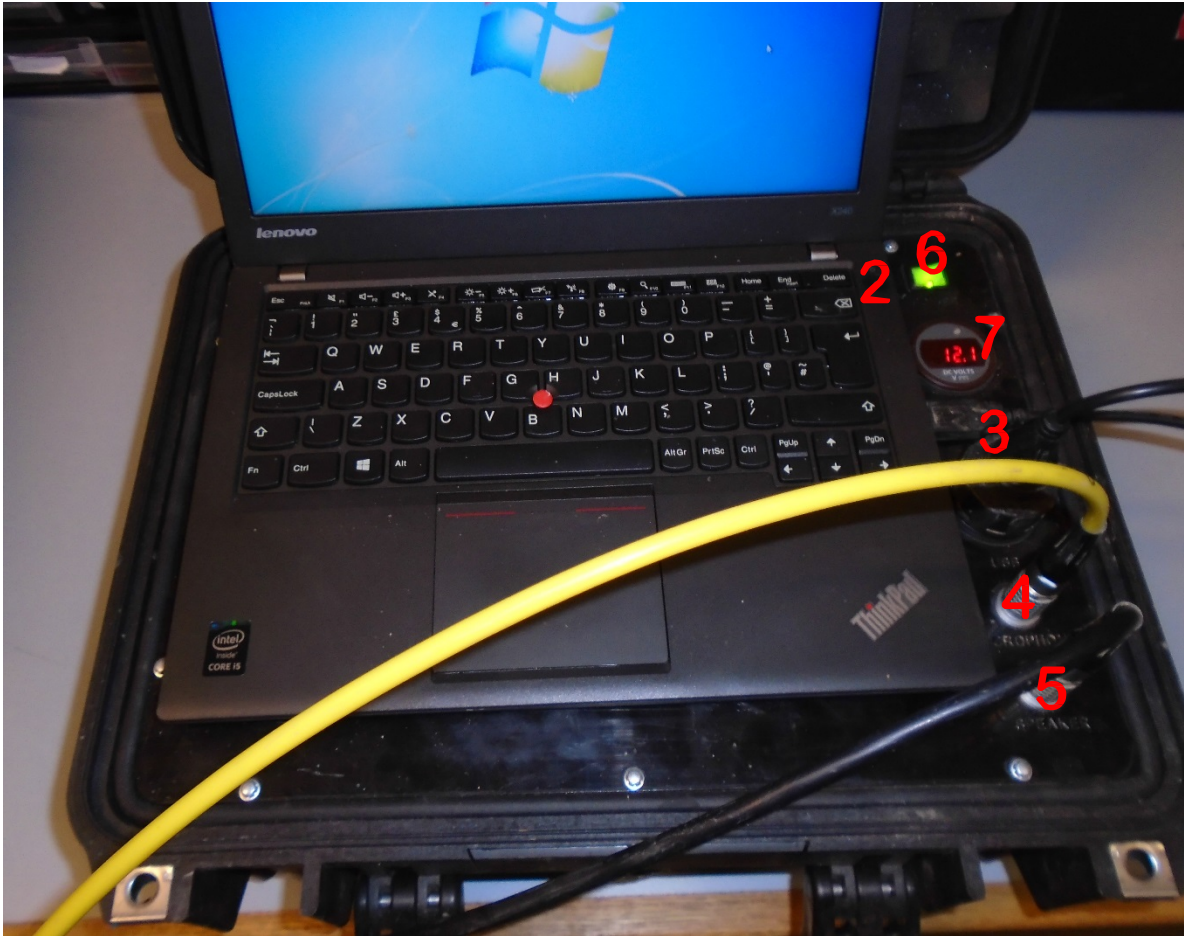
Figure 1 – Taking Measurements – steps 2 to 7 and correct Peli front panel cable connections

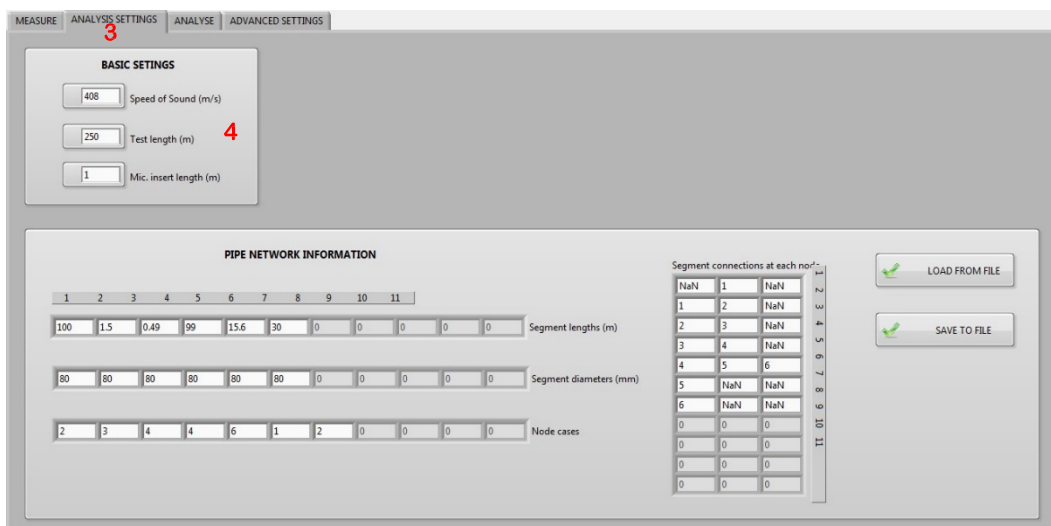
Figure 3 – Loading results - steps 3 and 4

1. Turn on laptop.
2. On the desktop double click the icon labeled “EIC SOFTWARE”.
3. Go to the “ANALYSIS SETTINGS” tab (Figure 3).
4. In the “BASIC SETTINGS” box set the speed of sound, test length and insert length that apply to the test result to be loaded (Figure 3).
5. Go to the “ANALYSE” tab (Figure 4).
6. Click the “LOAD RESULT” button (Figure 4).
7. Select the file to be loaded and press “OK”.
8. Repeat steps 3 to 7 to load more results.
